**Acoustic Emission Weld
Monitor System**

Data Acquisition and Investigation

Final Report

CONTRACT NO. DAAK 30-78-C-0123

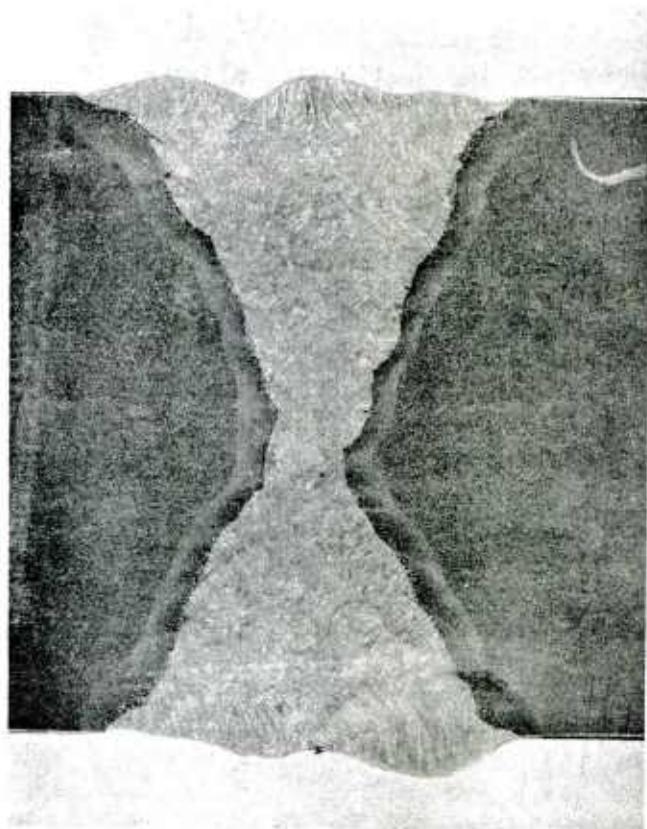
Radiographs of early welds also showed possible lack of fusion. Ultrasonic inspection revealed a consistent response about $\frac{1}{2}$ inch from the center of the plate probably at the weld-bevel interface. This was subsequently confirmed using metallography as shown in Figure 6. This flaw, running a significant portion of the weld length at a consistent location, suggested it might be related to weld pass geometry in addition to weld parameters. This problem was cured by slight modification of the pass map and maintenance of the minimum possible weld voltage to insure penetration and fusion.

Figure 6 METALLOGRAPHIC SECTION SHOWING
NATURAL LACK OF FUSION

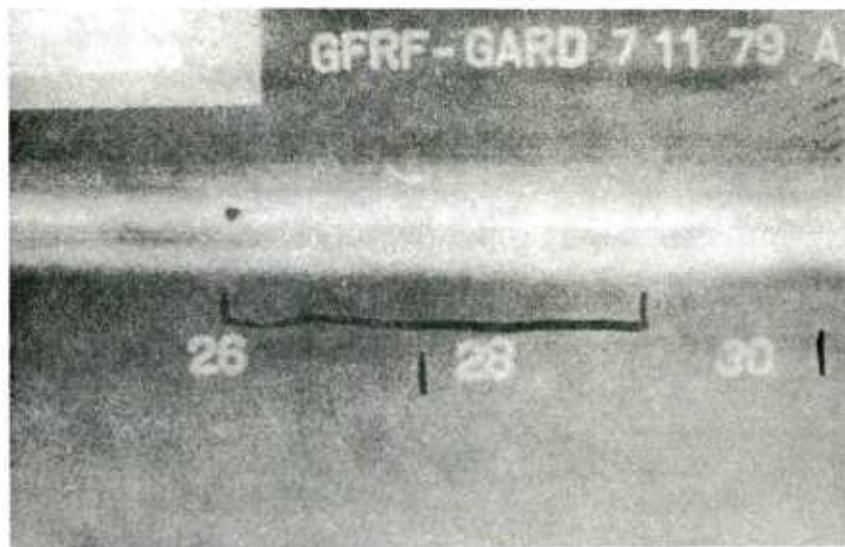
Figure 11 RADIOGRAPHY - INCOMPLETE PENETRATION
FULL PENETRATION WELD A/PT-12

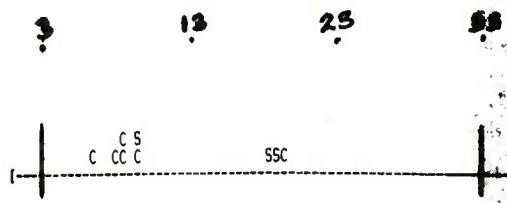
An example of crack detectability is shown in Figure 14. The cracks induced in side two of this partial penetration weld (A/PT6) were in pass 3: 18 inches into weld, and pass 4: 8 inches into weld. Using a cpa = 3, note the stack-up of detection at about the 18-19 inch point during pass 3, and at the 6 to 9-inch mark on pass 4. Additional AE responses detected during pass 3 are attributed to natural flaw formation as confirmed by radiography. The induced cracks clearly stand out as a stack-up of AE events.

a) CRACK DETECTION AT 18"

Figure 14 CRACK DETECTION

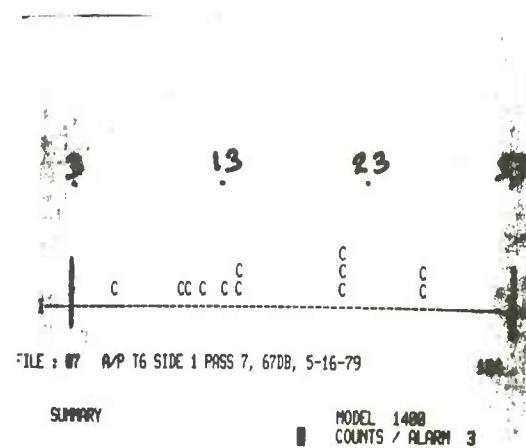
Crack growth during subsequent weld passes is also detectable often times more so than during the original flaw generation. One such example is shown in Figure 14b where the crack induced at 18 inches (Figure 14a) reactivates clearly in the subsequent pass as shown by indications in the center of the figure. An additional example is shown in Figure 15, side one, pass 7 of the same weld, where responses were received both at the 9-14 inch and 21-22 inch marks. These are reactivations of two cracks induced earlier: pass 3 at 12 inches into weld, and pass 4 at 24 inches into weld. Two additional radiographically confirmed flaws were also detected on this pass at the 6 inch and 28 inch points on the weld. As shown, cracks are indeed acoustic sources and can be detected.

Figure 15 CRACK REACTIVATION DETECTION

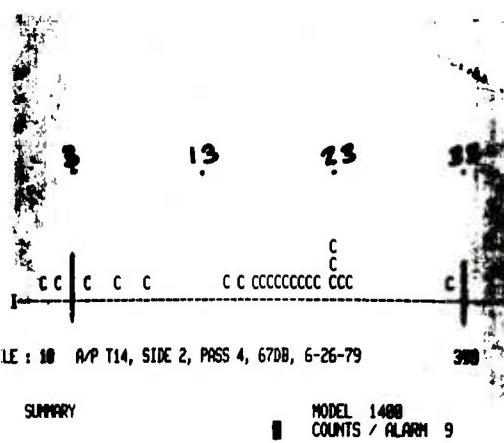
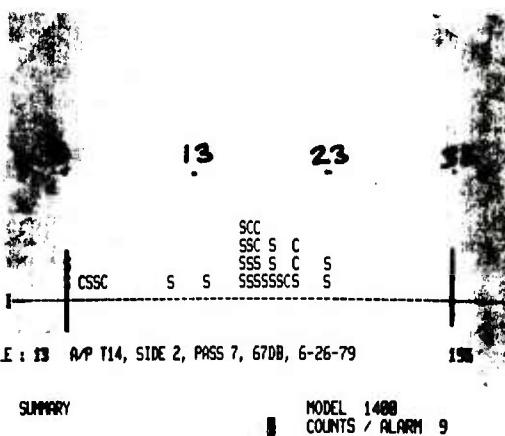
Detection of porosity was empirically determined to occur primarily during generation. A minimal amount of AE activity was sensed on subsequent passes. The large quantity of AE data generated during porosity induction may be useful in flaw discrimination. Figure 16 shows the results of AE detection during the generation of two areas of porosity on weld A/PT-14, side 2, pass 4 at 17-24 inches, and side 2, pass 7 at 16-23 inches. A count per alarm of nine was used due to the high rate of AE data. Responses at the beginning of both weld passes are caused by natural flaws.

Figure 16 POROSITY DETECTION

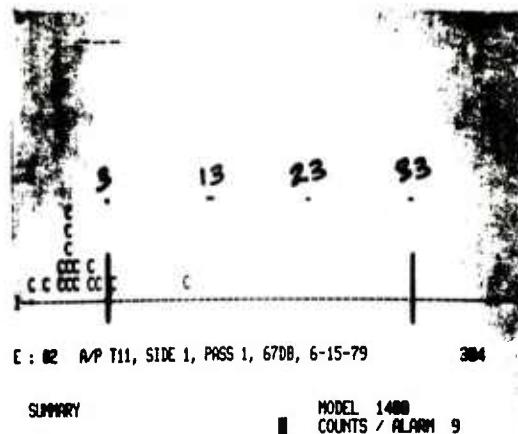
The second pass of this weld, using a cpa = 4, shows three significant peaks, one at weld start, one at 9-16 inches and the remaining centered at the 24 inch mark as shown in Figure 19. Reactivation of the pass 1 incomplete penetration (in the 12-20 inch range) at 11-15 inches is indicated. Radiographically confirmed porosity correlates with the AE peaks at the 24 inch mark. AE at the weld start indicates newly generated porosity, possible reactivation of porosity from pass 1, and other confirmed natural flaws generated during weld startup.

Figure 17 POROSITY DETECTED AT START OF WELD
CONTAINING INCOMPLETE PENETRATION

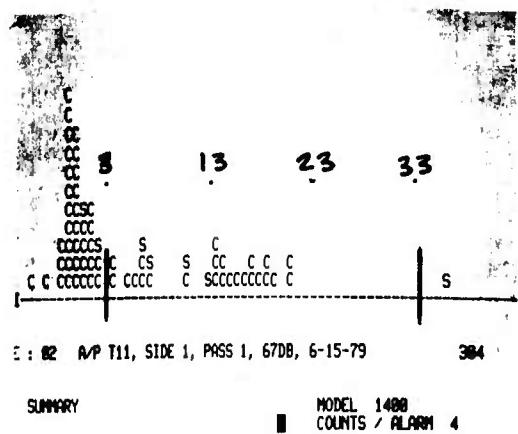
Similar results were obtained with the full penetration weld (A/PT-12). One incomplete penetration flaw generated, and confirmed radiographically, was in the side two, root pass, 22-30 inches into the weld. The most significant AE detection from the flaw was in the second, reactivating, pass, shown in Figure 20 (16-30 inches). Again, natural flaws were present in the end of the weld and to a lesser extent during the first half of the weld. These appear radiographically as porosity and produce resultant AE data.

Figure 18 INCOMPLETE PENETRATION DETECTED

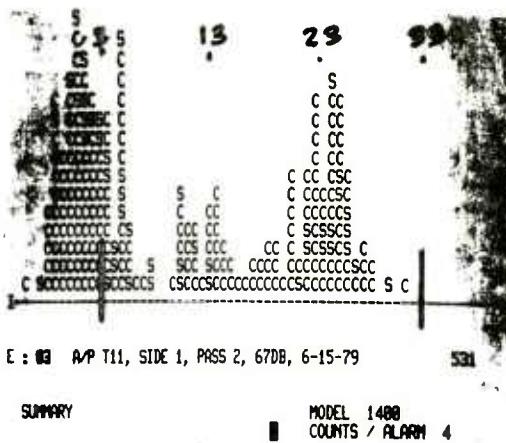
Figure 19 FLAW DETECTION PARTIAL PENETRATION WELD

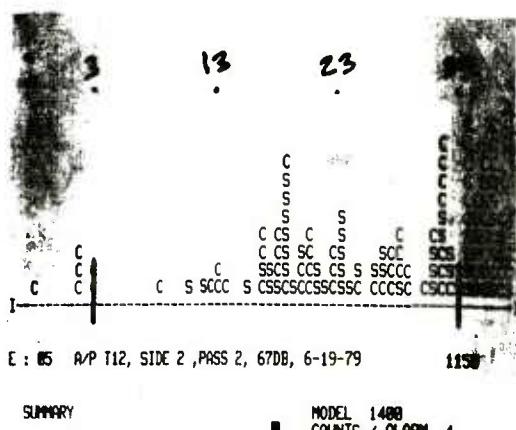
Figure 20 FLAW DETECTION FULL PENETRATION WELD

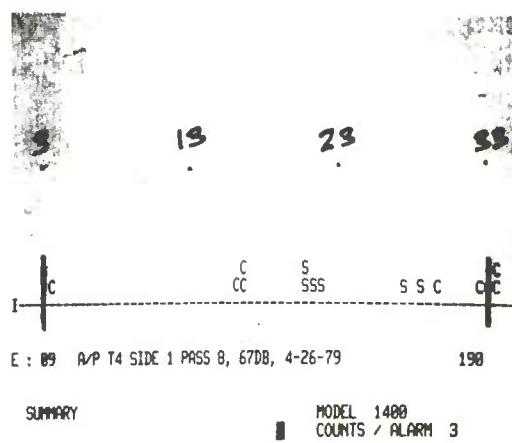
As cited earlier, only one radiographically confirmed intentional lack of fusion (LOF) was induced. There is, however, a significant population of natural LOFs; ten such natural flaws were apparent radiographically. It was found that LOF generates acoustic emission during both flawing passes and subsequent passes. Natural lack of fusion was most often embedded with other induced flaws. Where the natural LOF is not locationally isolated from the other flaws, data analysis is difficult. Two relatively isolated lack of fusion flaws were located radiographically in weld A/PT4. These were seen by AE in the 29 and 33 inch ranges of side one, pass 8 as shown in Figure 21. The response about 16 inch into the weld is due to the crack intentionally induced on this pass. The 3 inch and the 22 inch indications are additional radiographically confirmed flaws.

Figure 21 LOF DETECTION
